Engineering Failure Analysis 12 (2005) 420–431

Analysis of failed ethylene cracking tubes

Kaishu Guan *, Hong Xu, Zhiwen Wang

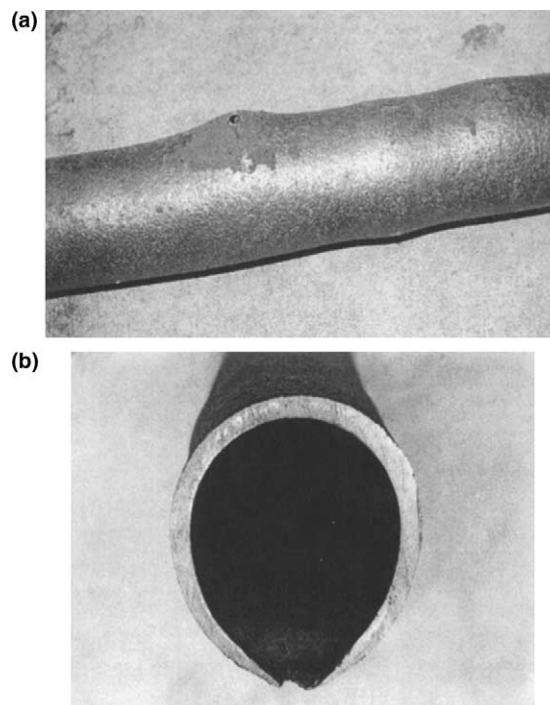
Fig. 1 shows the actual bulge and rupture of as received sample. The local bulge has penetrated as shown in Fig. 1(a). Cross-sectional view of the bulge tube is shown in Fig. 1(b). Tube diameter is now increased and

elliptical. This is an extraordinary amount of deformation. It is consistent, however, with a tube that has operated at higher than normal temperatures for short periods. Fig. 2(a) shows the penetrated crack with about 2 mm open. Fig. 2(b) shows the crack viewed on the tube inner surface. The crack is discontinuous in inner surface. The penetrated crack is longer in outer surface than that in inner surface which indicates the crack originated from outer surface. There is no indication of any localized damage in the form of pits. No wall thinning and plastic deformation is observed near the crack which reveals that the crack is brittle in nature.

Fig. 1. Tube bulge of as received sample: (a) general view; (b) cross-section.

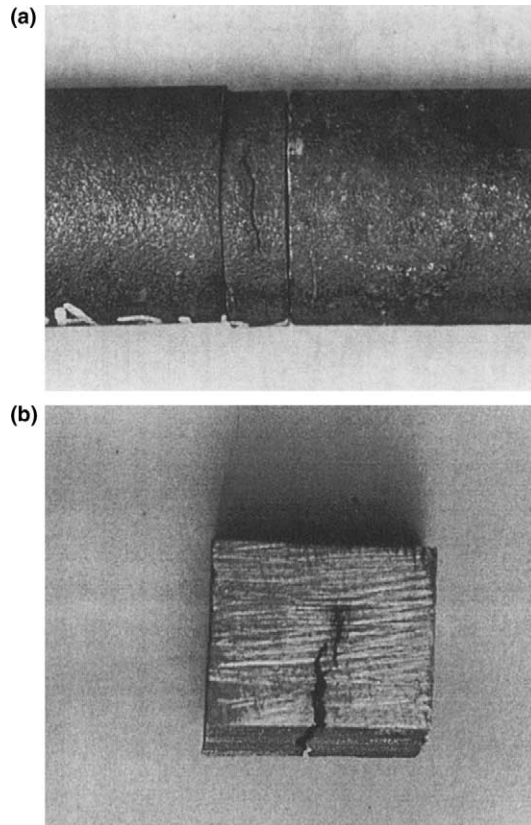
Fig. 2. circumferential crack at: (a) outer surface; (b) inner surface.

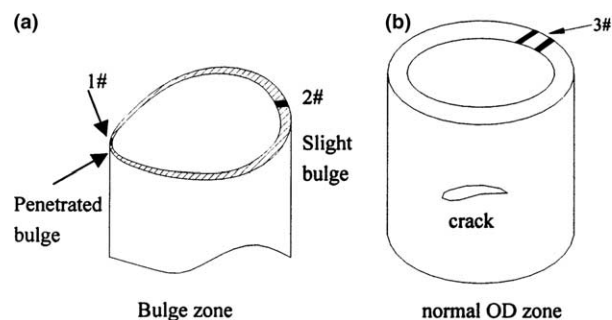
In order to compare the microstructure between the bulged zone and normal OD zone, optical metallographic samples prepared from the different sites as shown in Fig. 4. 1# sample was cut from immediately near the penetrated bulge zone along the cross-section. 2# and 3# samples were cut from slightly bulged zone and normal OD zone, respectively.

Fig. 4. Location of microstructure observation.

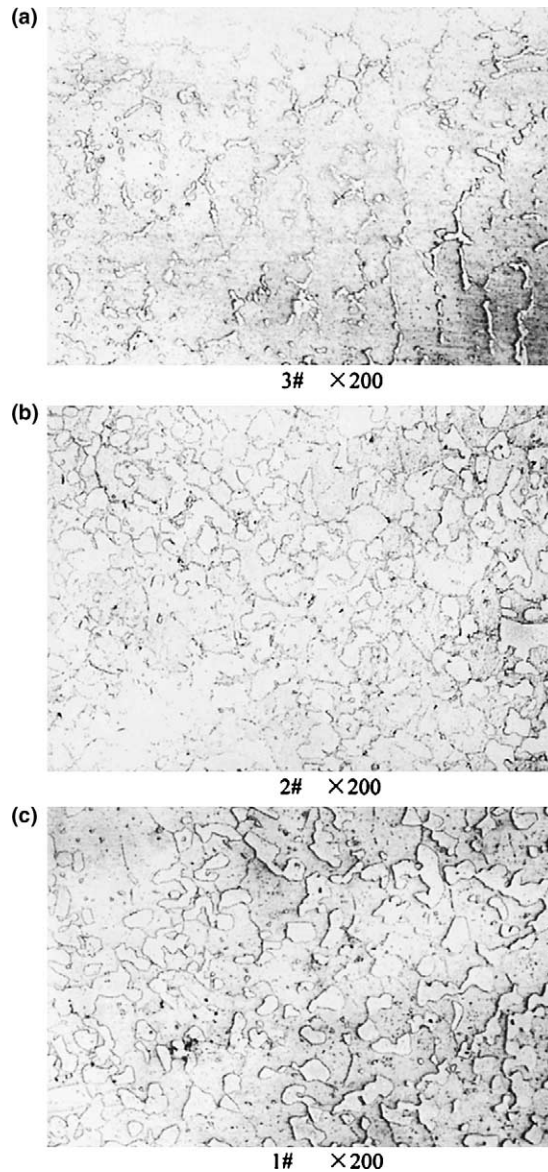
Fig. 5(a) shows austenite matrix and a network of primary carbides of 3# sample, which is the typical microstructure of as-cast materials of alloys with high chromium and nickel contents [8,9]. But precipitates of small blocky type are found in the austenitic grains. Fig. 5(b) shows the microstructure of 2# sample. Carbides are obviously coalesced and blocky which indicates overheating. This is more pronounced in ruptured side as is shown in Fig. 5(c) of 1# sample, suggesting that it had experienced more overheating. Creep cavities and carburization are not obvious in the LOM observation.

Fig. 5. Microstructure of section of failed tube.

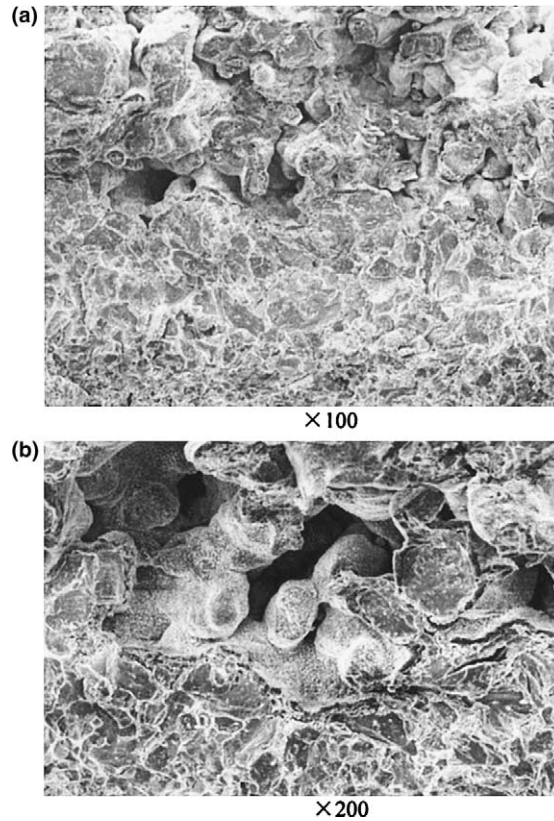
Fig. 6(a)–(b) shows the SEM photography of bulged penetration surface. The rupture shows intergranular fracture. The grains have a globular form with increased size due to oxidation and overheating. This can be further proved by scanning electron microscopy (SEM)/energy dispersive spectroscopy (EDS) analysis as is shown in Table 3. Because these tubes are heated externally by burners, the outer surfaces of the materials are exposed to oxidizing conditions, thus oxygen and chromium are the main composition of the grain surface. Fig. 7 shows a newly opened crack immediately near the penetrated bulge. The high-temperature oxidation is not so serious as compared with Fig. 6(a)–(b), but large amount of precipitates is present. The fractography showed, in general, brittle fracture mode. The fracture is along precipitates which is rather brittle and has secondary cracks.

Fig. 6. Globular grains due to melting.

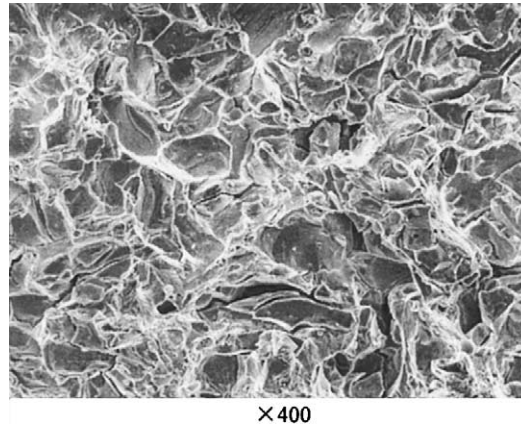
Fig. 7. SEM of newly opened crack immediately near the penetrated bulge.

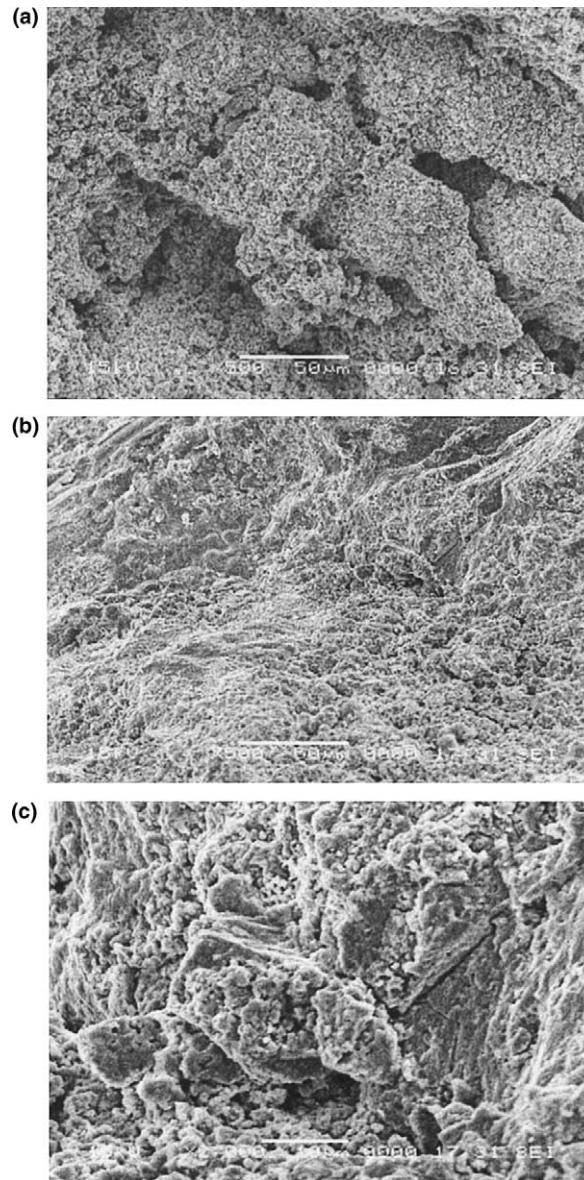
Fig. 8 presents fractography of the circumferential crack. The surface has been oxidised and has creep cracks as shown in Fig. 8(a). The general view shows overloaded ductile fracture as is presented in Fig. 8(b) on another position. The detailed morphology of Fig. 7(b), shown in Fig. 8(c), however, shows the crack propagating along the precipitate. The cause can be explained as follow. Since matrix metal around these precipitates possesses good ductility and toughness, when the fracture takes place along these precipitates, the surrounding metal matrix presents ductile fracture. So the fractography looks like overloaded ductile fracture in general view.

Fig. 8. SEM photography of fractured surface: (a) general view of creep cracks; (b) general view of fracture surface; (c) details of the crack surface.

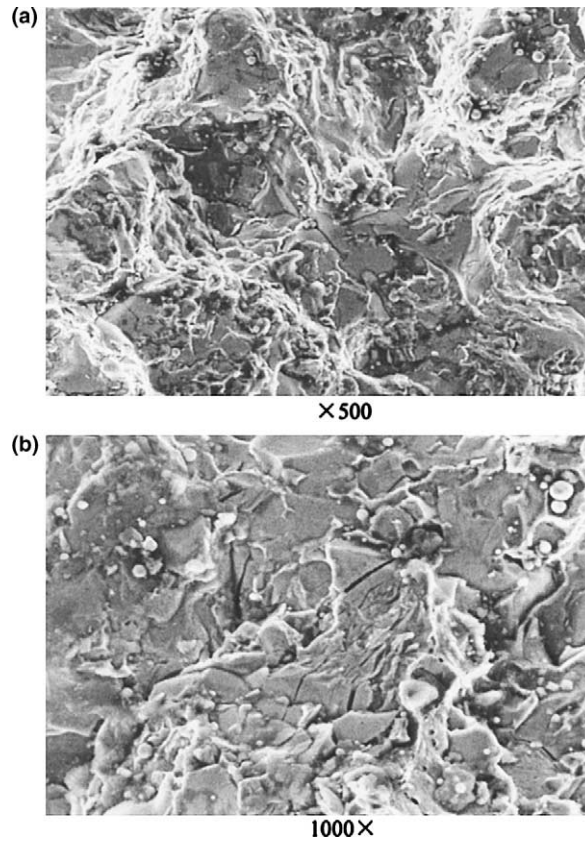
Fig. 9 shows the micro-morphology of a tensile specimen at room temperature. The fracture surface is covered by a large amount of precipitates. These precipitates are rather brittle and give secondary cracks. The fractography showed, in general, brittle fracture mode.

Fig. 9. SEM surface of tensile specimen.

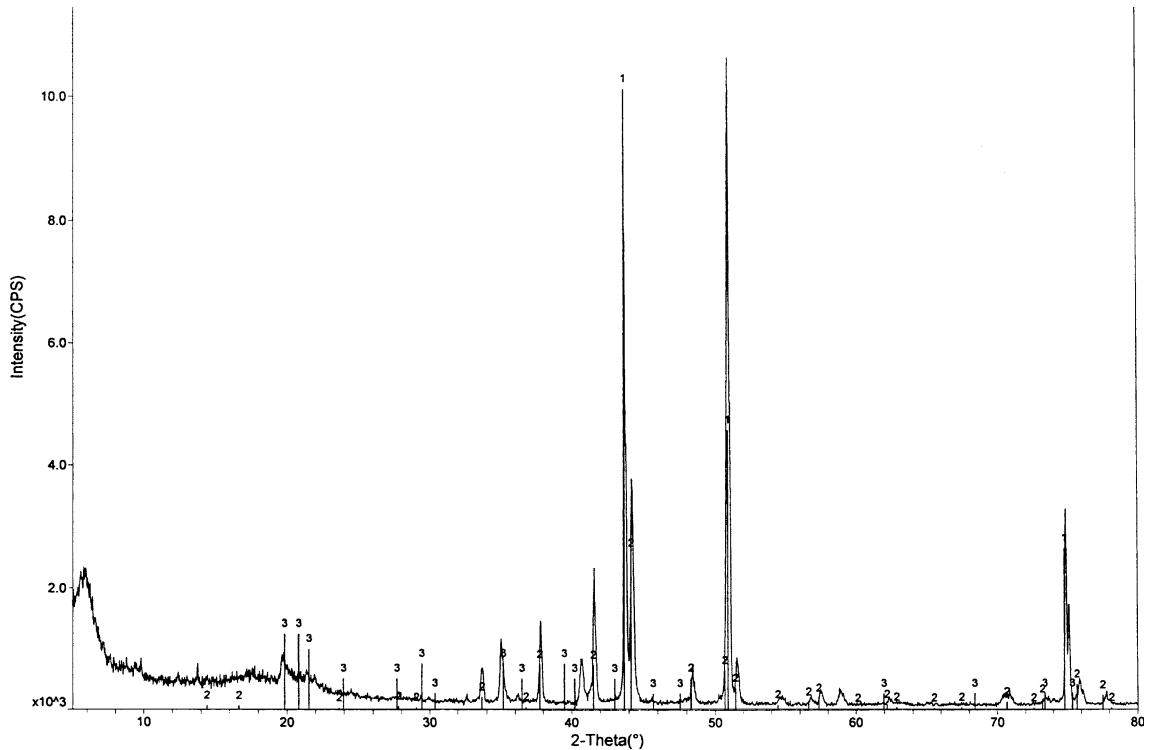
XRD patterns obtained from the bulk metal matrix show that the precipitates are mainly Cr_{23}C_6 carbide (Fig. 10).

1: Austenite, 2: Cr_{23}C_6 -Chromium Carbide, 3: could not be identified, probably is pollutant.

Fig. 10. XRD pattern of precipitate.

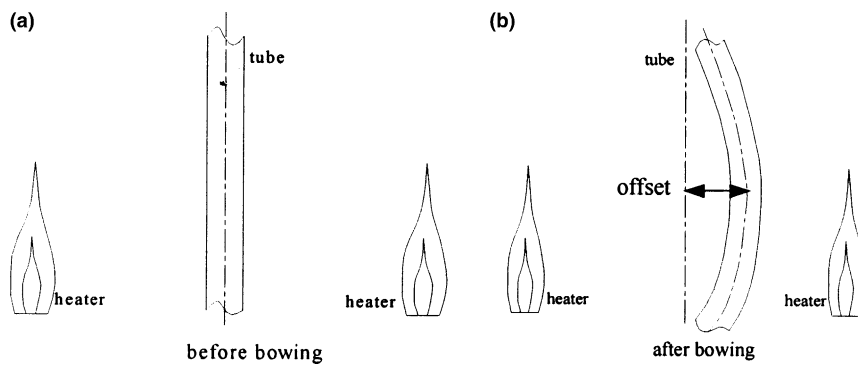
Overheating at the elevation of 5 m can cause bulges, however, the circumferential cracks in the tube are caused by not only overheating but also the tensile stress effect and reduction of ductility. The user reported that all of the failed tubes were similarly bowed when they failed. When the tube bows significantly out of plane, it is exposed excessive radiant heat as is shown in Fig. 11. The heaters are distributed at the two sides of the furnace. Generally, the tubes suffered the same temperature at two sides. However, due to tube bowing, one side is closer to the heaters than the other side. The closer side of tube will therefore operate at a higher temperature and be more likely to overheat and fail. Higher temperature will also cause the tube to grow and bend further, putting it into compression. Tube outer surface suffer from tensile stress at the bowing side as is shown in Fig. 11, thus the crack initiated from this side and from outer surface. Once the crack is formed, the crack tip is exposed directly to high-temperature oxidation. The strength of grain boundaries deteriorates and promotes intergranular cracks.

Fig. 11. Schematic drawing of tube bowing.

The overheating is directly related to the bottom burners. The burners should be improved in one or two of the following ways. One is to adjust the ratio of heat intensity between the bottom burners and wall burners thus reducing the flame intensity at about 5 m height and making the temperature more uniform along the tube axis. The second way is to improve the burning conditions of the bottom burners and decrease the peak tube metal temperature.
