Common failures in gas turbine blades

Tim J Carter *

Abstract

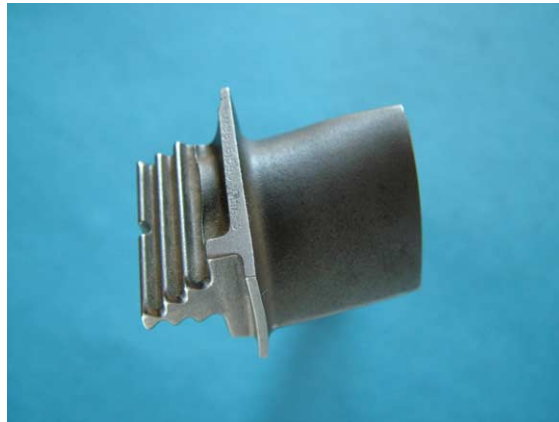
Fig. 1. A typical high pressure gas turbine blade.

The components most commonly rejected are the blades from both the compressor and the turbine (Fig. 1), and the turbine vanes. The reasons for this are fairly straightforward and are due to two principal causes, these being damage caused by ingested materials and damage due to the temperature of operation. Failures through mechanical mechanisms such as fatigue are rare, unless initiated by abnormal circumstances.

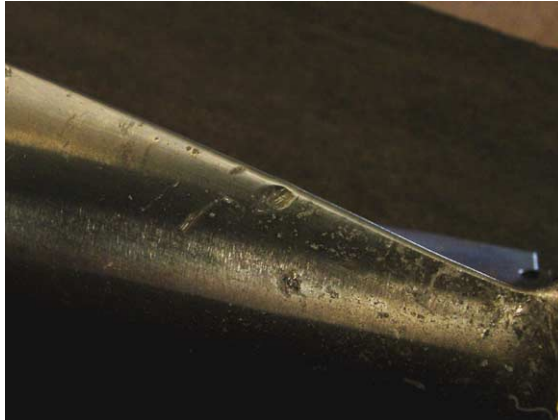
Fig. 2. Mechanical damage caused by ingested foreign material on the leading edge of a compressor blade.

Any gas turbine engine ingests large amounts of air when in operation, either sucked in by the compressor or rammed in by the forward motion of the aircraft. In either event, any solid material entrained with the air will cause damage through either erosion or impact (Fig. 2). In most applications, filtration is not possible, although coarse screens to keep out the largest pieces are used in some applications.

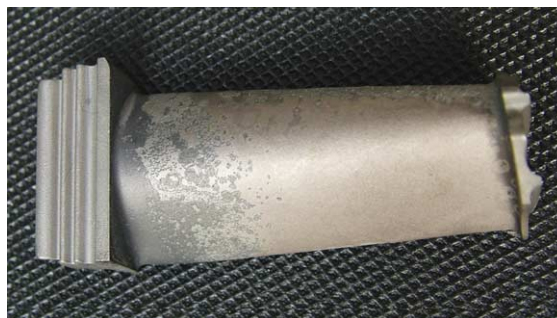
Fig. 6. Sulphidation attack of a turbine blade. Such damage can sometimes be repaired by removing the damaged coating and re-applying a new coating.

Both compressor and turbine blades are exposed to aggressively corrosive conditions (Fig. 6). The ingested air may well contain sodium and chlorine, in the form of salt from sea air or from runway de-icing treatments or marine environments. Atmospheric contaminants result from natural sources, such as marine environments or through pollution from industry or forest fires, and usually contain sulphur and sodium as the most active elements. Volcanic activity can generate significant levels of pollutants, particularly sulphur.
