# Evaluation of WC–17Co and WC–10Co–4Cr thermal spray coatings by HVOF on the fatigue and corrosion strength of AISI 4340 steel

## Abstract

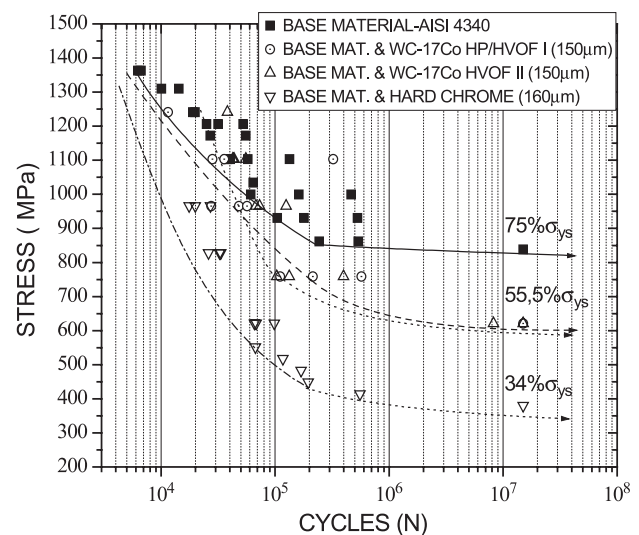
Fig. 2. Axial fatigue  $\sigma \times N$  curves. Base material (■); base material coated with WC–17Co by HP/HVOF I process (○); base material coated with WC–17Co by HVOF II process (△); and base material electroplated with hard chromium (▽).

Fig. 2 shows axial fatigue  $S-N$  curves for base material, base material electroplated with hard chromium, 160  $\mu\text{m}$  thick, base material with WC–17%Co spray coating by HP/HVOF I process, 150  $\mu\text{m}$  thick, and base material with WC–17%Co spray coating by HVOF II process, 150  $\mu\text{m}$  thick.

Analysis of the experimental data indicated in Fig. 2 revealed the significant reduction in the fatigue strength of AISI 4340 steel, associated with the chromium electroplating. This behavior may be attributed to the high tensile internal residual stress, microcracks density and strong adhesion coating/substrate interface. Tungsten carbide thermal spray coating applied by HP/HVOF I process, considered in this research as an alternative to chrome plating, had also a reduction effect on the axial fatigue strength of AISI 4340 steel.

According to the experimental data represented in Fig. 2, the reduction in fatigue life of coated material with WC–17%Co, is more significant in high cycle than in low cycle fatigue tests and the fatigue resistance of the substrate material is less affected by both WC–17%Co spray coated by HP/HVOF I and HVOF II processes, 150  $\mu\text{m}$  thick, respectively, than by hard chromium electroplating, 160  $\mu\text{m}$  thick.

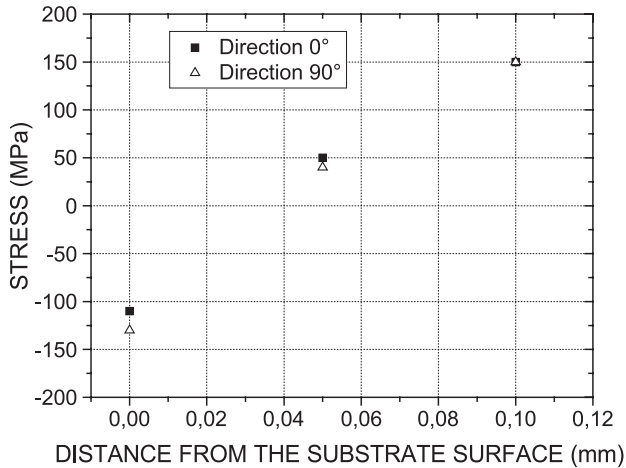
Fig. 10. Through thickness internal residual stress. WC–10Co–4Cr I process.

Fig. 10 shows internal residual stresses in the substrate for specimens coated with WC–10Co–4Cr applied by HP/HVOF I process.

Experimental results in Fig. 10 indicate, in the same way as data from Table 2, compressive internal residual stresses at coating/substrate interface, increasing into the base metal becoming tensile at around 0.03 mm from the interface.

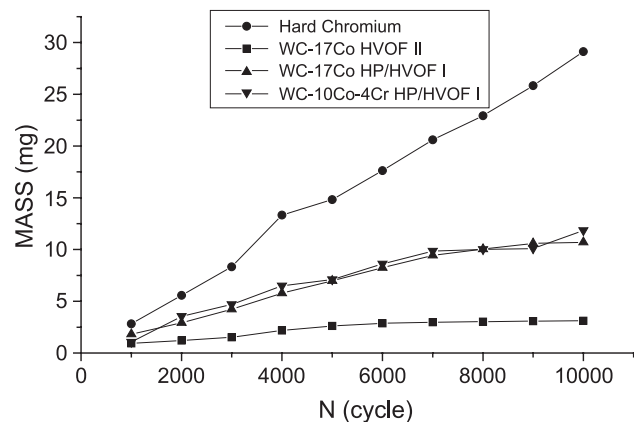
Fig. 13. Abrasive wear weight loss versus number of cycle.

The abrasive wear resistance of hard chromium plating, WC–17%Co spray coating by HP/HVOF I and II processes and WC–10Co–4Cr spray coating by HP/HVOF I process were evaluated and results in terms of wear weight loss are represented in Tables 4–7 and in Fig. 13.

One sees the better performance of samples coated with WC, with lower-wear weight loss than the hard chromium-electroplated specimens. This behavior may be attributed to the higher hardness and oxide content into the tungsten carbide coating [16].

Higher microhardness values for WC–17Co spray coating by HVOF II in comparison to HP/HVOF I and hard chromium electroplating explain the results shown in Fig. 13. The wear weight loss for hard chromium electroplating is also associated to the microcrack density. Coating of high oxide content is usually harder [16] and is more wear-resistant [12]. Initially, in the first 1000 cycles, an almost equivalent value of wear weight loss was observed for tensile carbide coatings and hard chromium electroplating. A compensation effect between microhardness and higher-surface roughness of the tungsten carbide coatings, in comparison to the electroplate hard chromium, was responsible for this behavior.

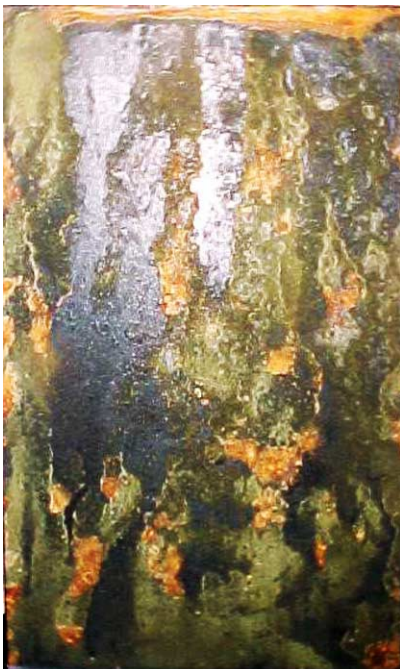
Fig. 14. Salt spray tests results for WC–17%Co HVOF I, 250  $\mu\text{m}$  thickness.

Results of corrosion testing performed in a qualitative way were obtained by visual inspection of the specimen surface exposed to salt spray. For the WC–17%Co HP/HVOF I specimen, 250  $\mu\text{m}$  in thickness, the coating did not quite protect the substrate against the aggressive action of salt spray environment, as indicated in Fig. 14, which shows corrosion products on the sample surface. The same behavior was observed for thickness equal to 150 and 200  $\mu\text{m}$ .

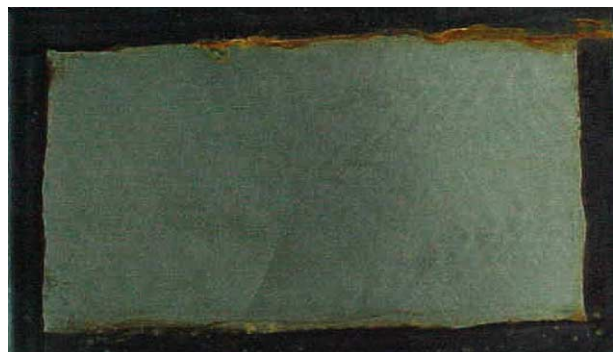
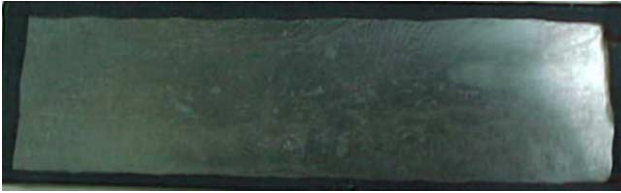
Fig. 16. Salt spray tests results for WC–10Co–4Cr, 150  $\mu\text{m}$  thickness.

Fig. 17. Salt spray tests results for WC–10Co–4Cr, 200  $\mu\text{m}$  thickness.

The salt spray test results for samples WC–10Co–4Cr coated, applied by HP/HVOF I process are shown in Figs. 16 and 17, for thicknesses equal to 150 and 200  $\mu\text{m}$ , respectively.

The surface aspect after salt spray testing indicated no visual corrosion and was observed on samples WC–10Co–4Cr coated.
